## **SR 527 MP 2.76 Queensborough Creek (WDFW ID): 993084 Final Hydraulic Design Report**

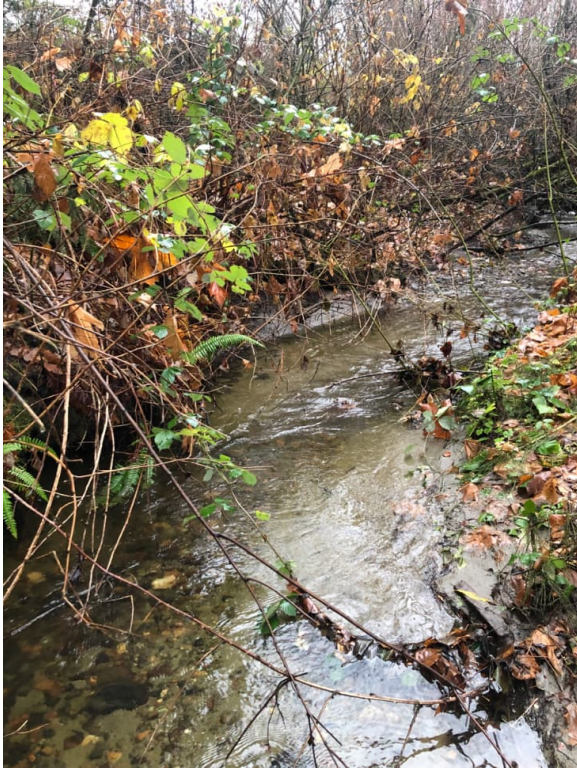
**Figure 2-6: Queensborough Creek habitat upstream of SR 527**

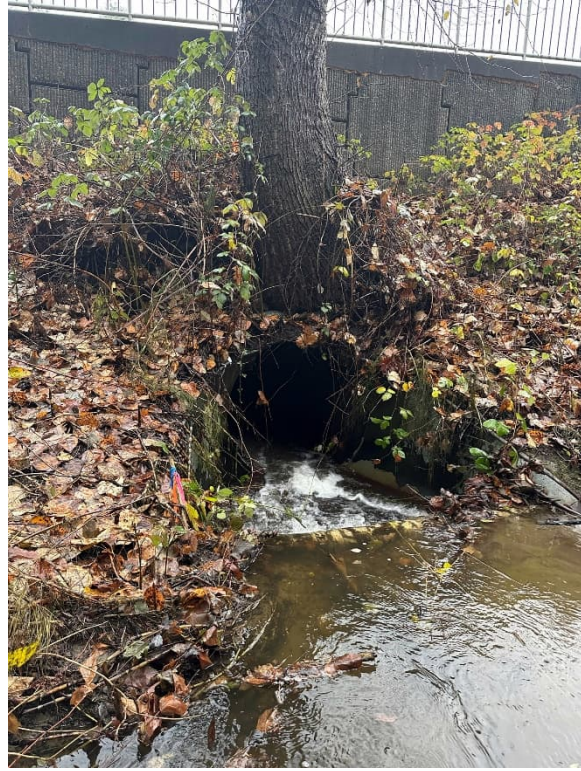
**Figure 2-7: Inlet of Queensborough Creek under SR 527**

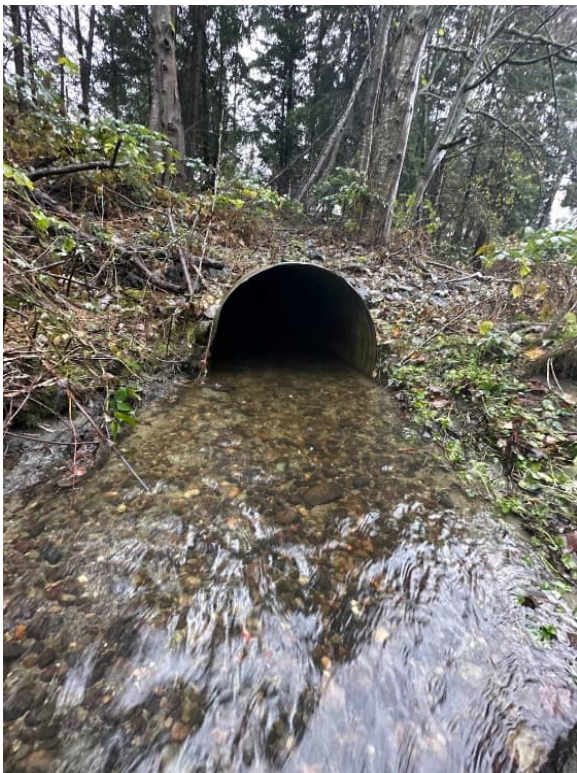
**Figure 2-8: Outlet of Queensborough Creek under SR 527**

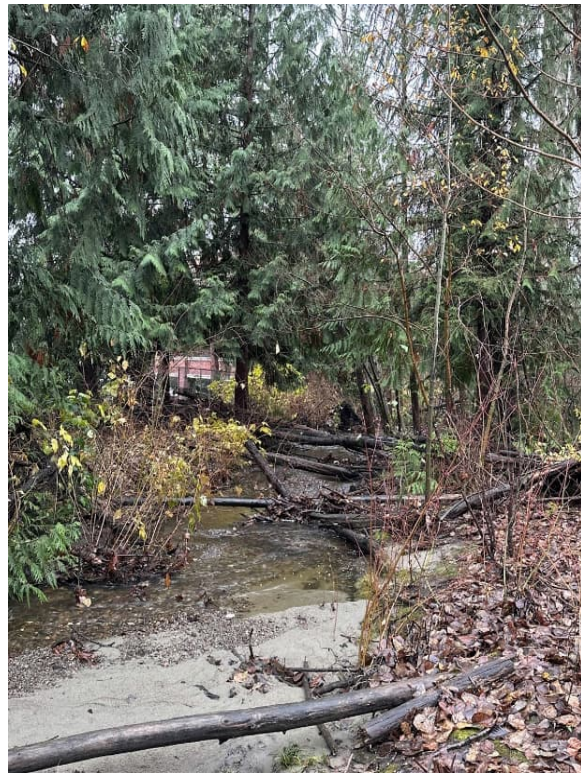
**Figure 2-9: Queensborough Creek habitat downstream of SR 527**

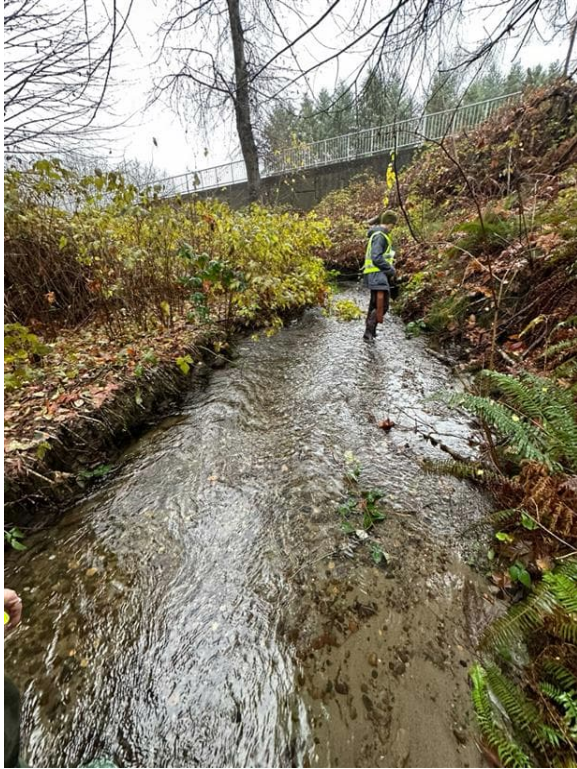
**Figure 2-11: Bankfull measurement location #15 (looking downstream)**

As described in **Section 2.6.1**, bankfull width measurements for Queensborough Creek were determined in the field on July 1, 2019, by WSDOT, WDFW, and MITFD. Bankfull width measurements were obtained from 10 locations within 500 feet upstream of the SR 527 crossing (**Table 2-3**). These measurements were taken approximately 30 feet apart. Measurements upstream of SR 527 ranged from 5.7 feet to 12.3 feet. The average bankfull width throughout the assessment area is 9.7 feet. These bankfull width measurements were corroborated during the 2023 AECOM site visit (**Figure 2-11**).

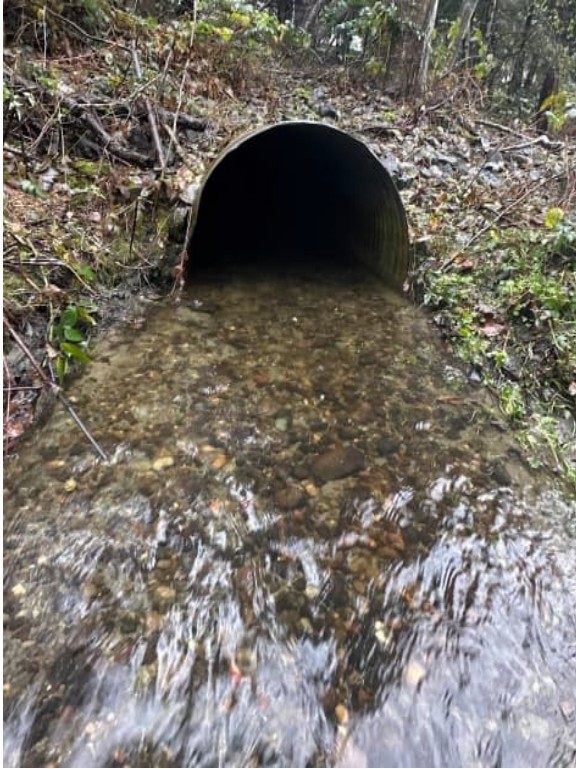
Figure 2-12: Sediment at SR 527 outlet

Sediment along the streambed and banks of Queensborough Creek vary in composition. Downstream from the SR 527 crossing, substrate contained a mix of fines, gravel, and high organic material content, with the most suitable spawning substrate found just downstream from the culvert (**Section 2.6.3**). Upstream from the SR 527 crossing, substrate predominantly consisted of gravels and cobbles. Additionally, it was evident that sands and fines were being conveyed through the system. There were several sand bars noted downstream from the culvert, and most of the banks directly adjacent to the creek consisted of sand and silt. Due to heavy sediment loading in the creek, spawning gravels tend to have high silt embeddedness which reduces habitat value. **Figure 2-12** and **Figure 2-13** show existing in-stream sediment at the culvert outlet and at the upper part of the surveyed reach.

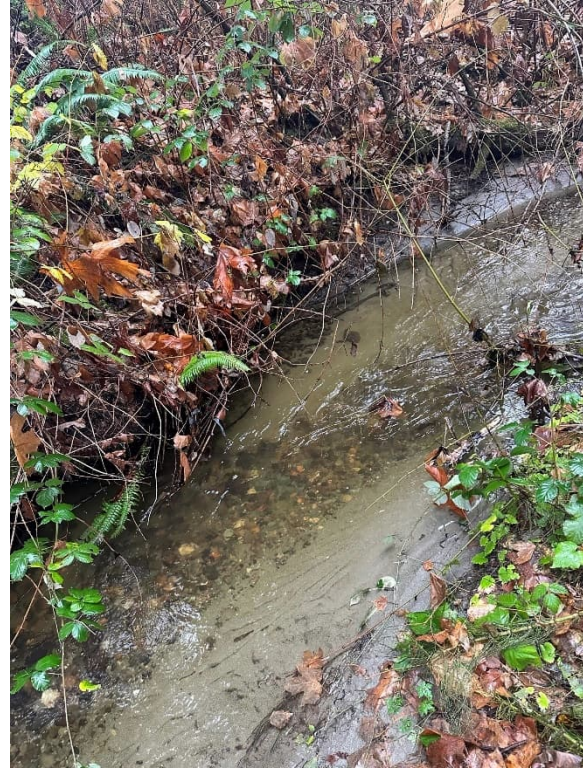
Figure 2-13: Sediment in Queensborough Creek upstream of SR 527

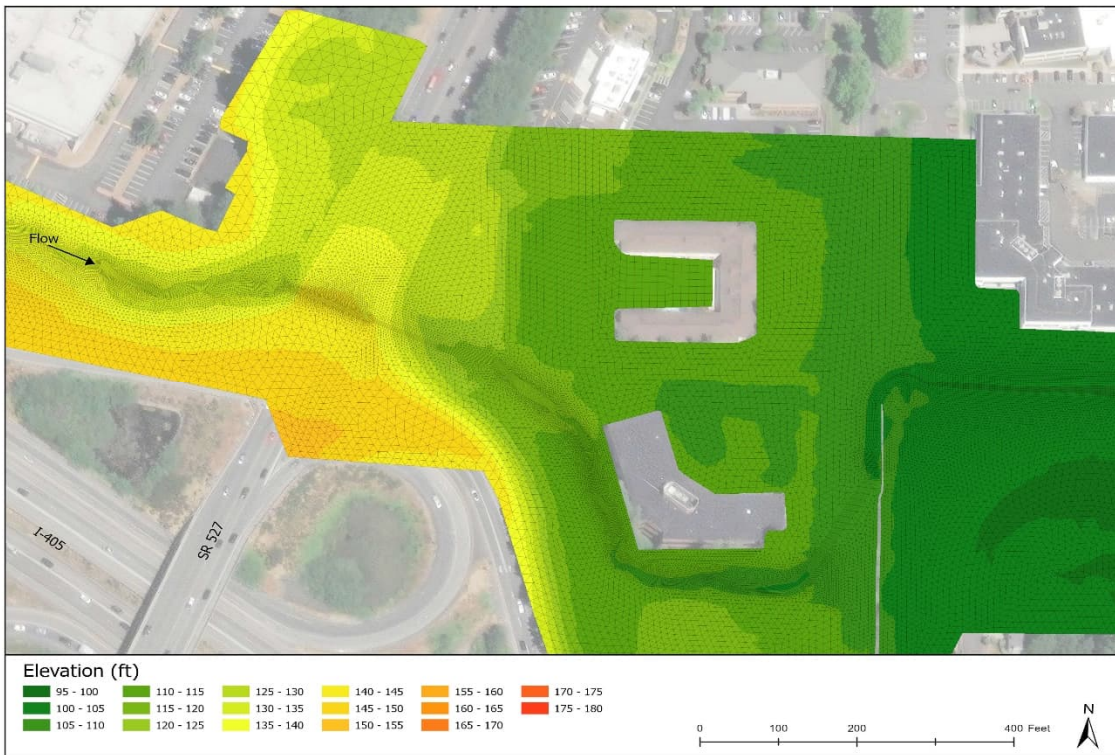
Figure 5-4: Eastern half of the existing condition SRH-2D mesh, including the crossing at SR 527

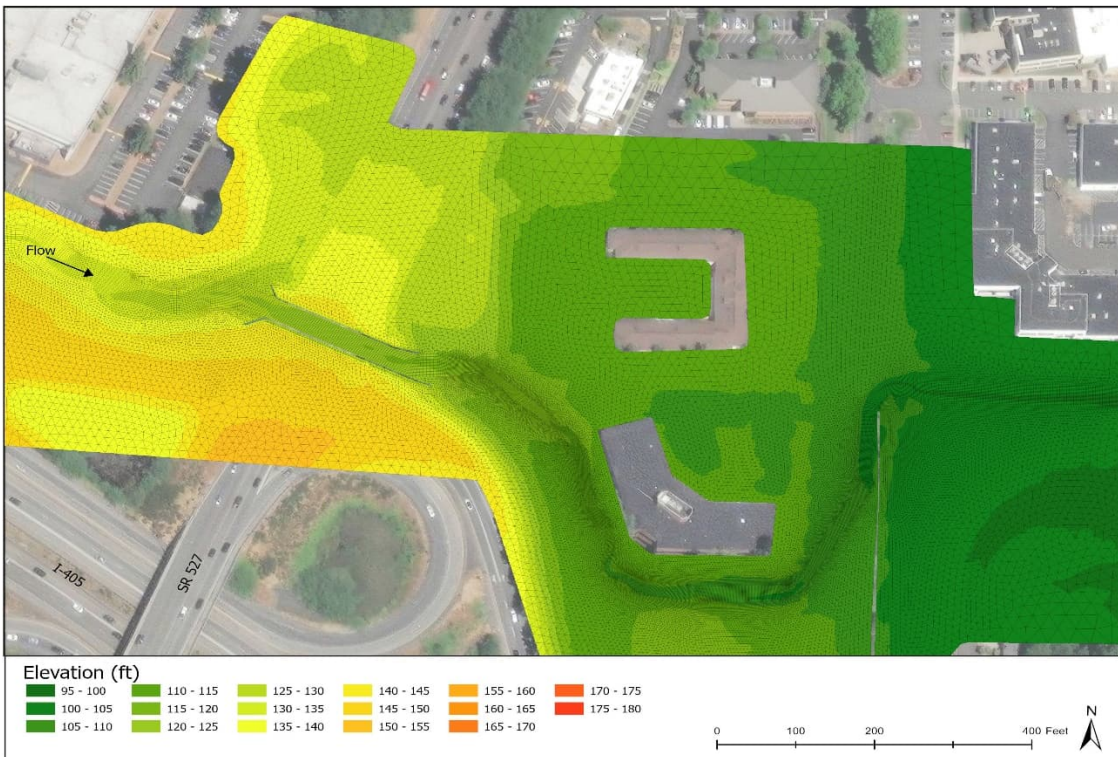
Figure 5-6: Eastern half of proposed condition SRH 2D mesh, including SR 527 crossing

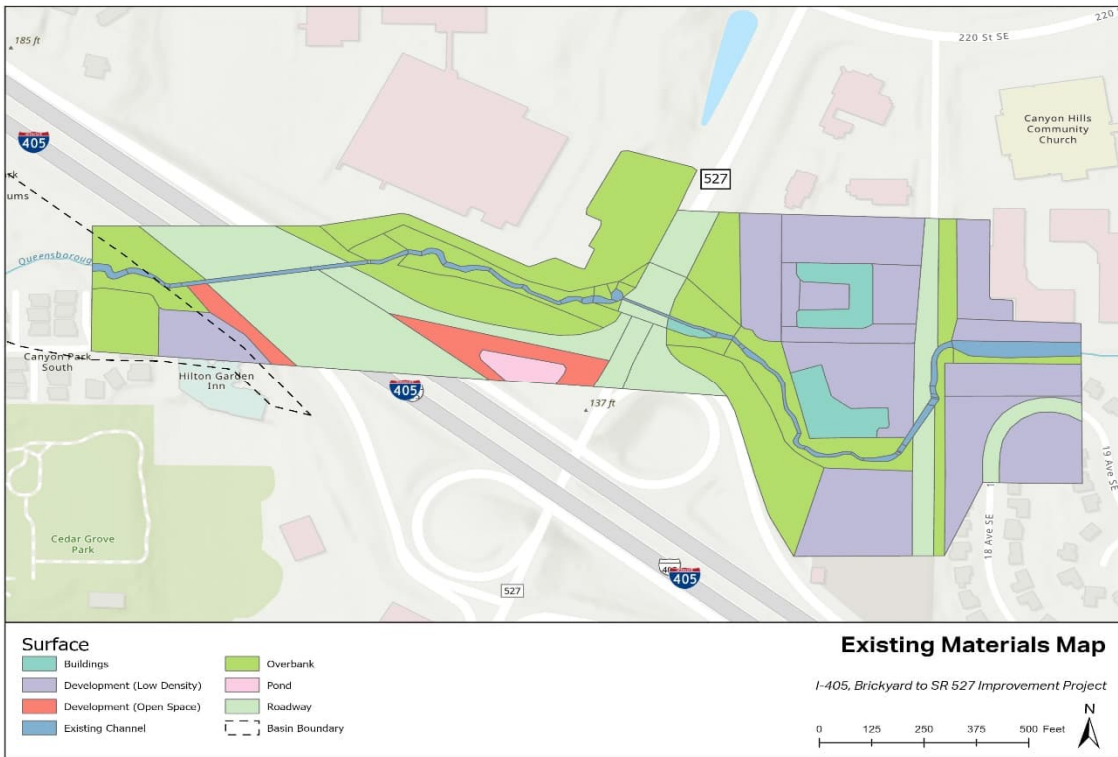
Figure 5-7: Spatial distribution of existing conditions roughness values
